Job No. 88175
Report No.: 1
Revision: 0

**SEISMIC RELIABILITY STUDY OF THE
SEATTLE WATER DEPARTMENT'S
WATER SUPPLY SYSTEM**

Seattle Water Department
Dexter Horton Building
710-2nd Avenue
Seattle, Washington 98104

Cynga Energy Services
2121 N. California Blvd.
Walnut Creek, California 94596

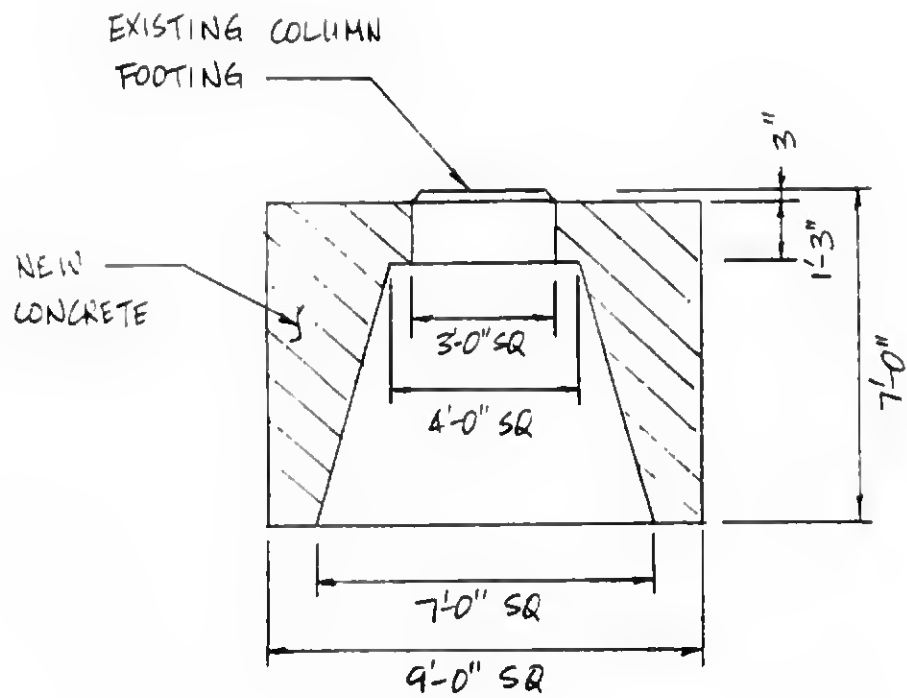
Figure 6.7-6

**Landsburg Elevated Water Storage Tank
Foundation Upgrade Alternative**

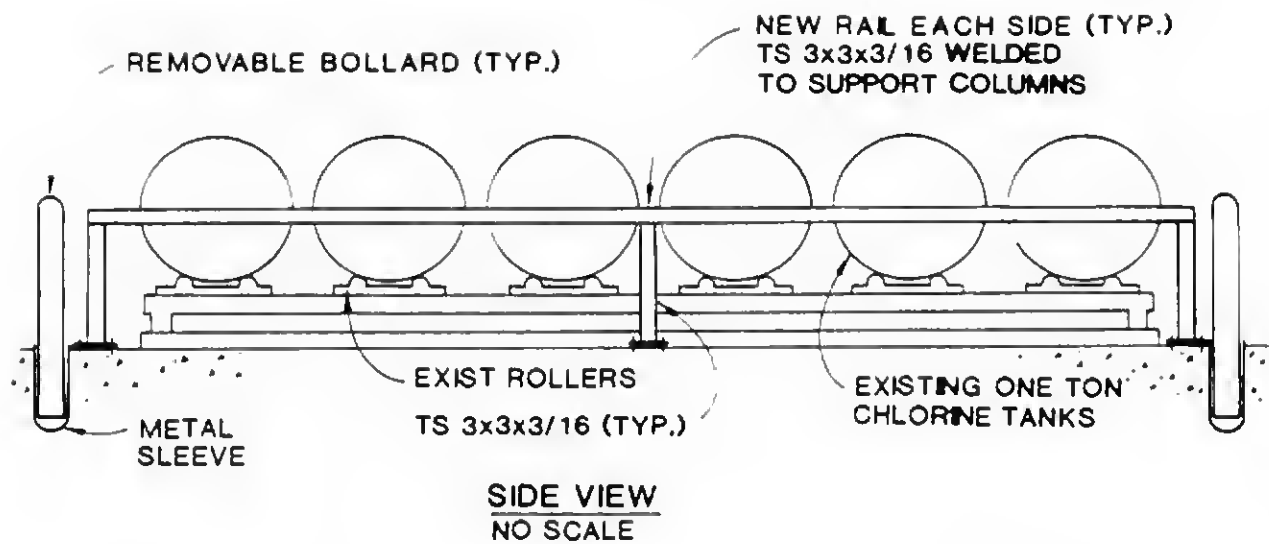
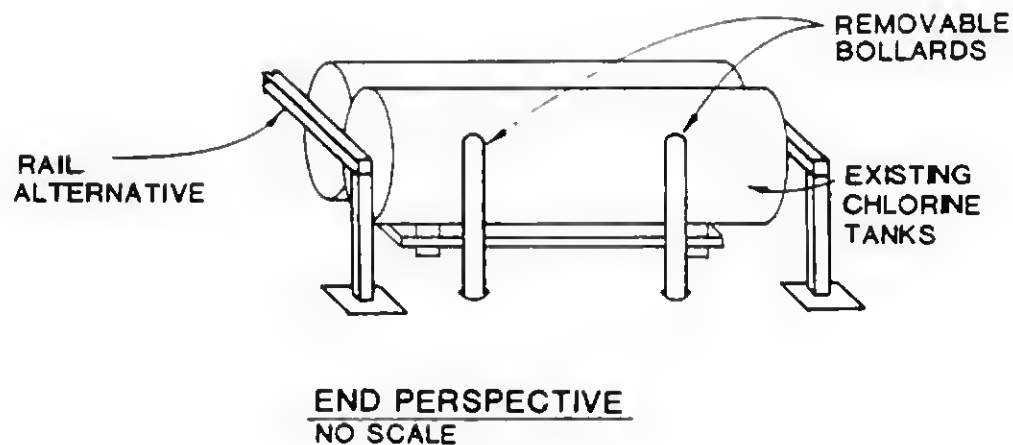
Figure 11.40-2

A common potential hazard was found in the chlorination facilities. The large chlorine tanks, supported on racks over scale pits, are not secured. The chlorine tanks could slide off their racks in an earthquake, rupturing the pressurized feeder lines and causing leakage of chlorine gas. Two alternative methods have been proposed for securing the tanks. The first is to wrap a strap around the tanks and tighten with a ratchet. The second is to construct removable reinforced bollards at each end of the tank racks, along with tube steel rail headers which are parallel to the tank rack on both sides. Either of these methods would prevent the tanks from sliding far enough to sever the feeder lines. The costs projected for securing the chlorine tanks in this report assume that both methods are used in combination.

Securing Chlorine Tanks - Removable Bollards and Side Rail Arrangement

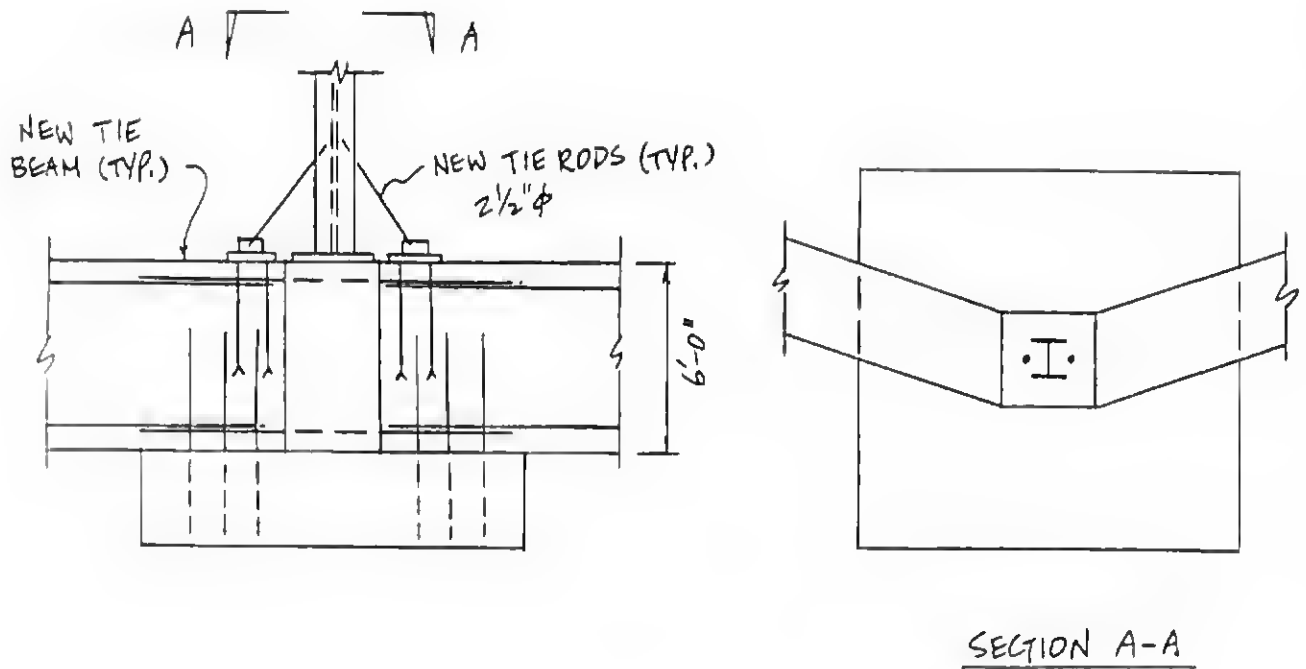
Figure 14.5-5

Maple Leaf Elevated Water Storage Tank
Conceptual Foundation Upgrades

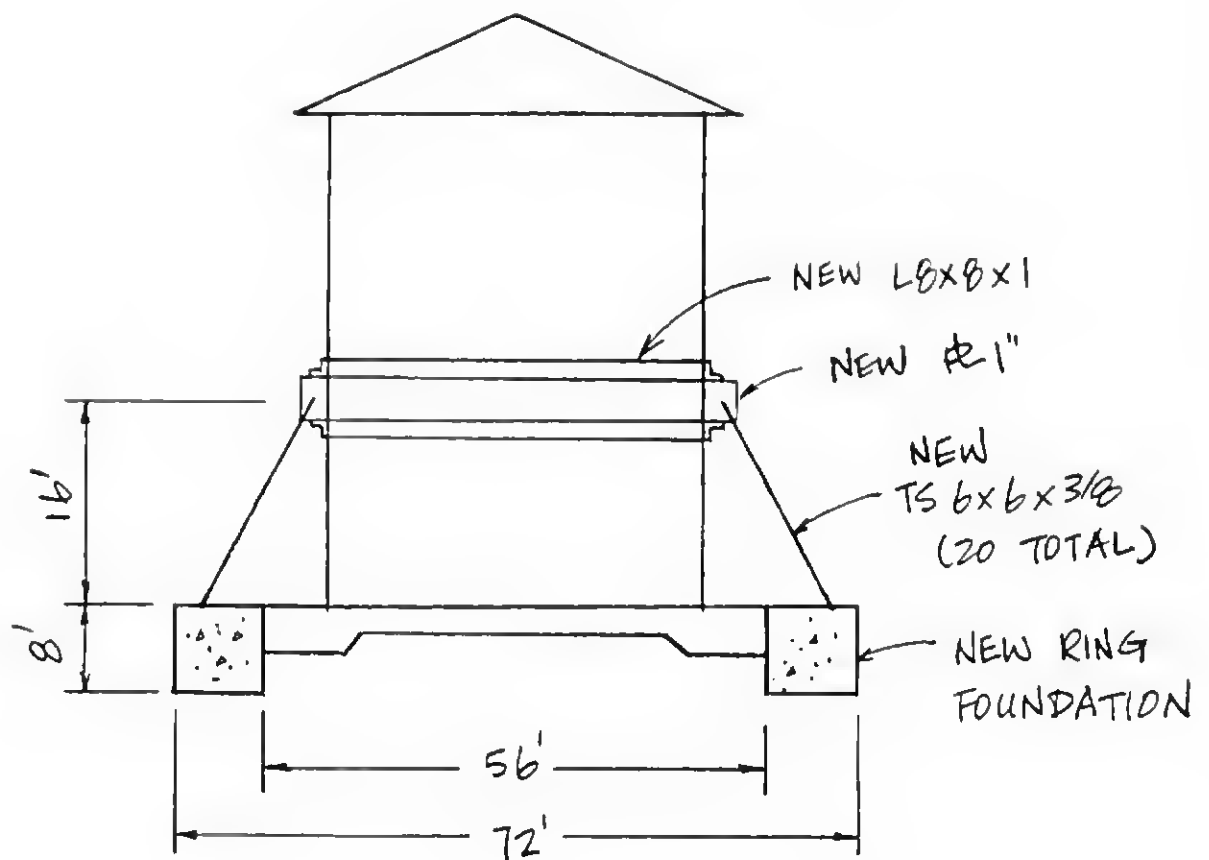
Figure 15.4-3

Charlestown Water Storage Standpipe
Conceptual Upgrade

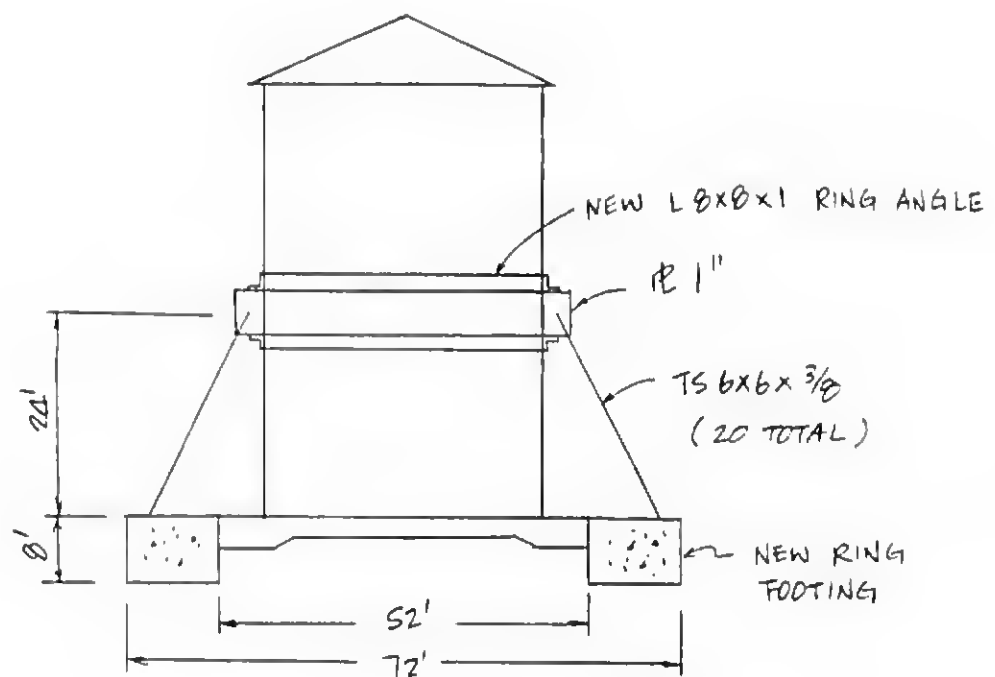
Figure 15.5-3

Foy Water Storage Standpipe
Conceptual Upgrade

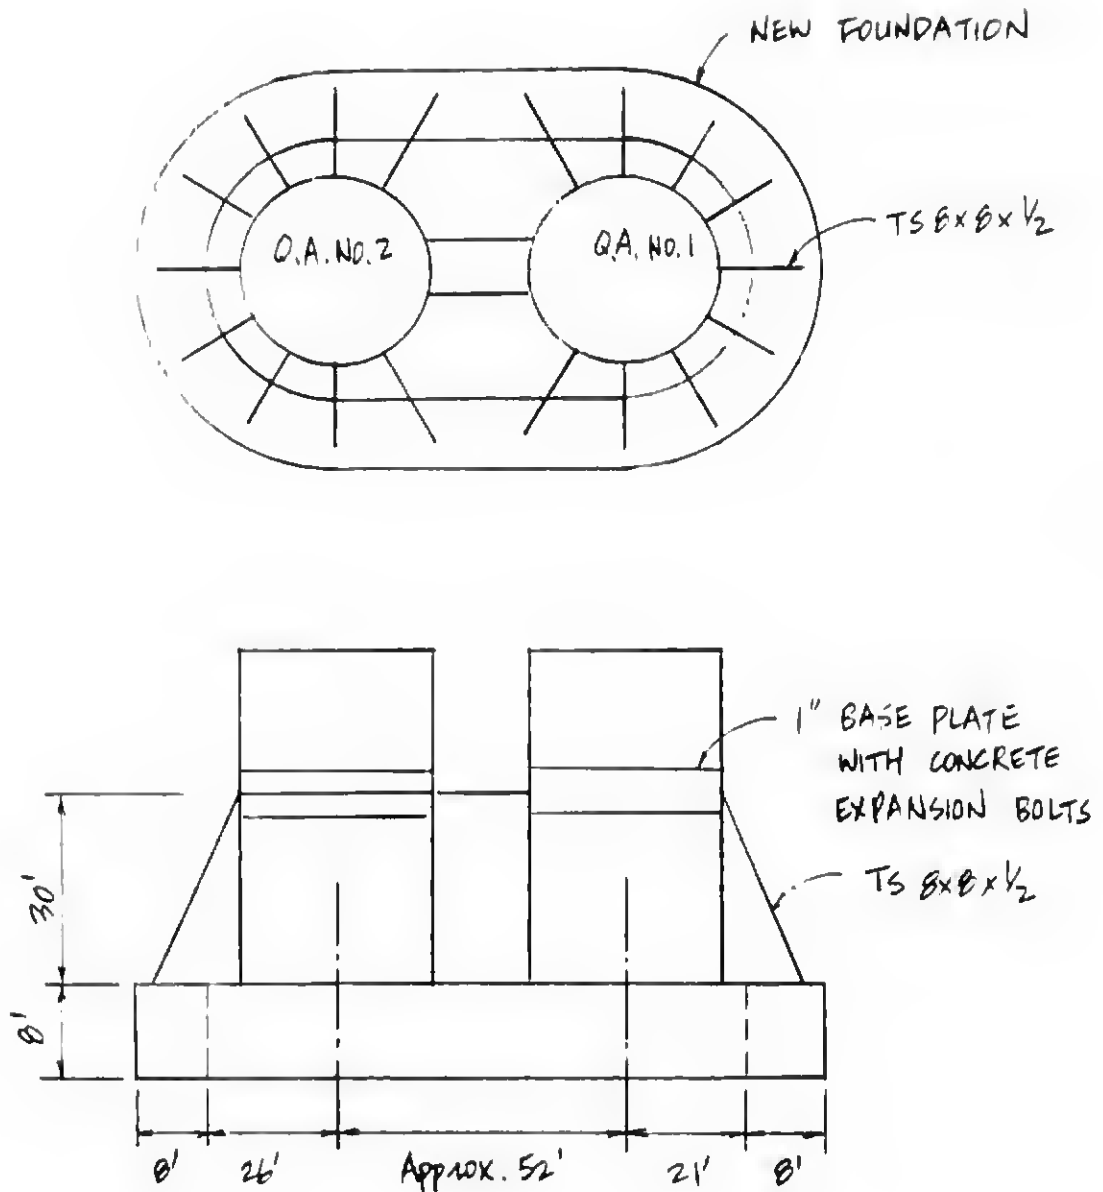
Figure 15.6-3

Queen Anne #1 and Queen Anne #2 Water Storage Standpipe
Conceptual Upgrade

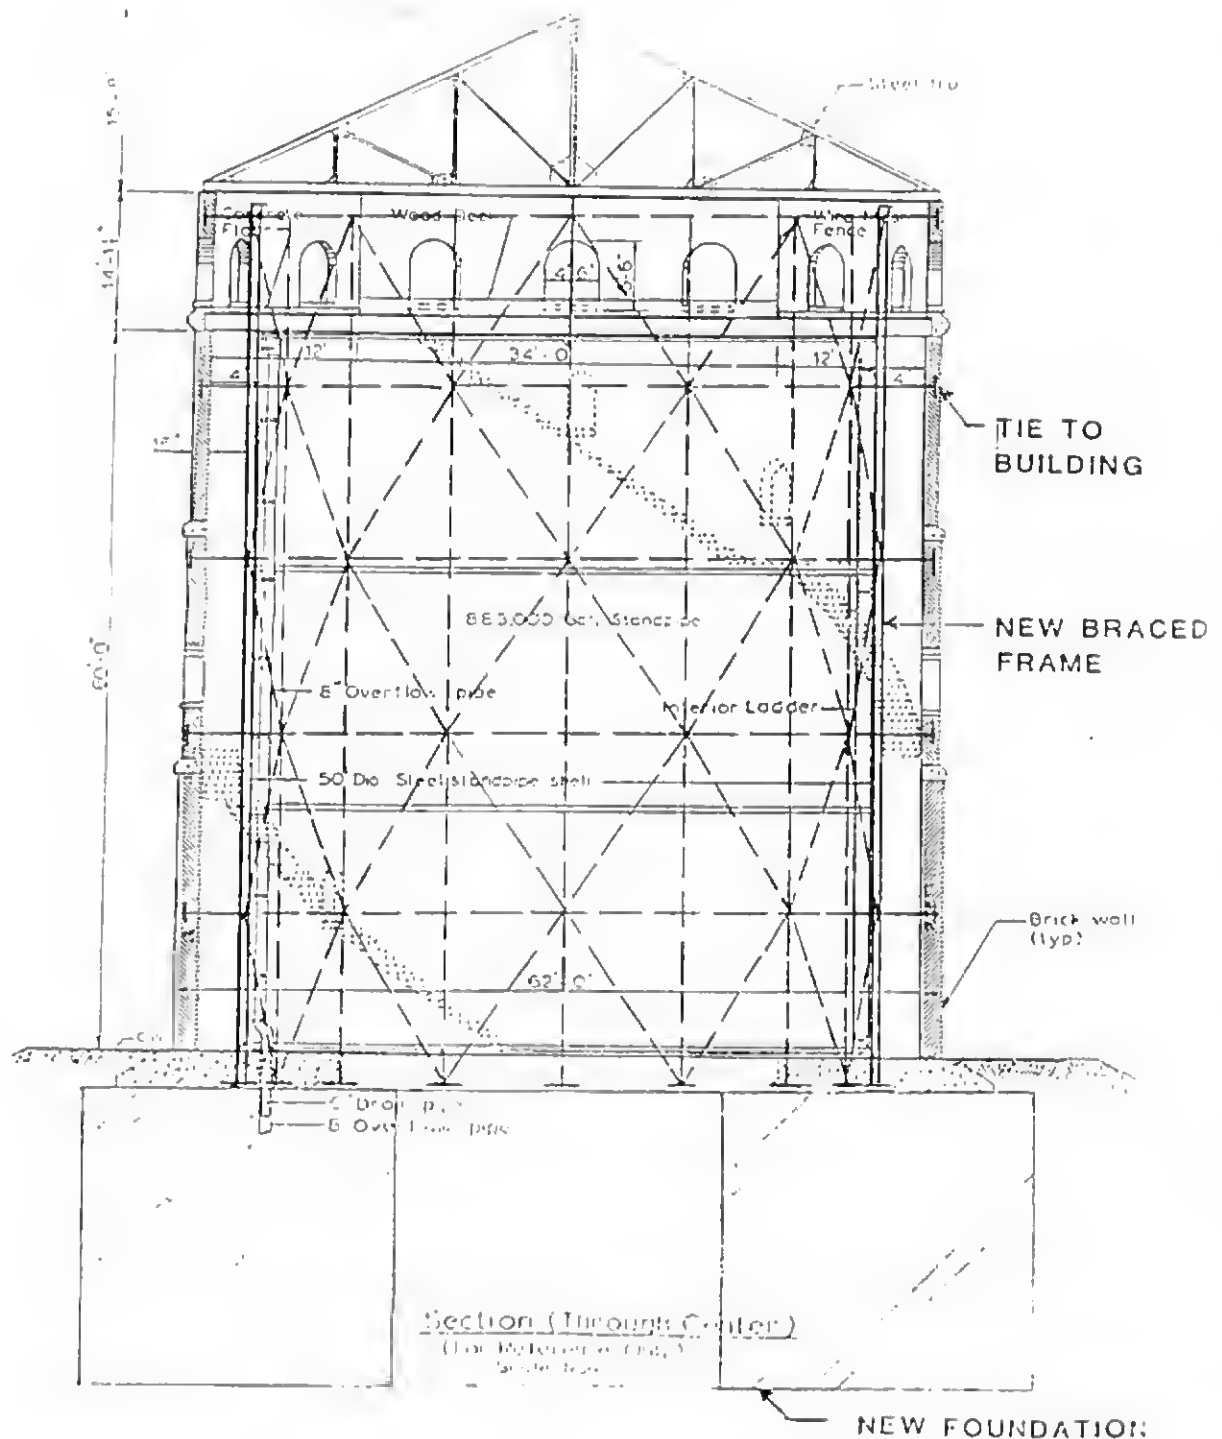
Figure 15.9-3

Volunteer Park Water Storage Standpipe Conceptual Upgrade
